# Bourbon Dolphin Tragedy – No Scope for Complacency

Bruce Craig  
Partner

Pinsent Masons

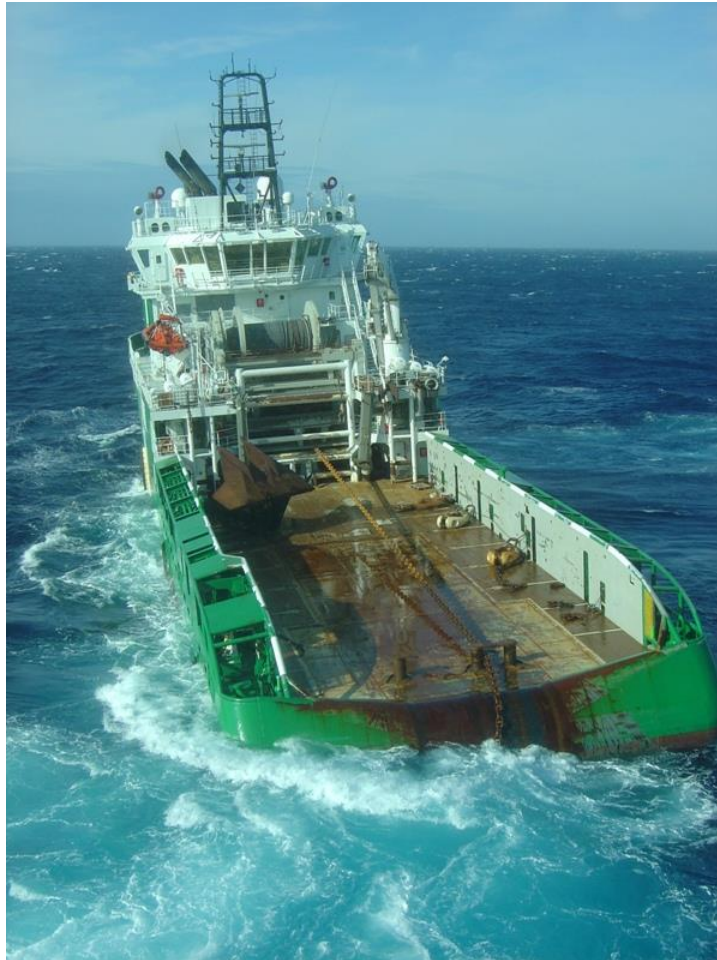
- 1500 – 1626 - Highland Valour assisted BD by grappling chain.
- 1626 - Close quarters situation between BD and Highland Valour – unseen by towmaster on rig's bridge and not reported to rig.
- Listing 5 degrees to port – transfer of ballast from port to starboard tanks.
- Towing between starboard pins.
- Outer port pin up and inner port pin down.

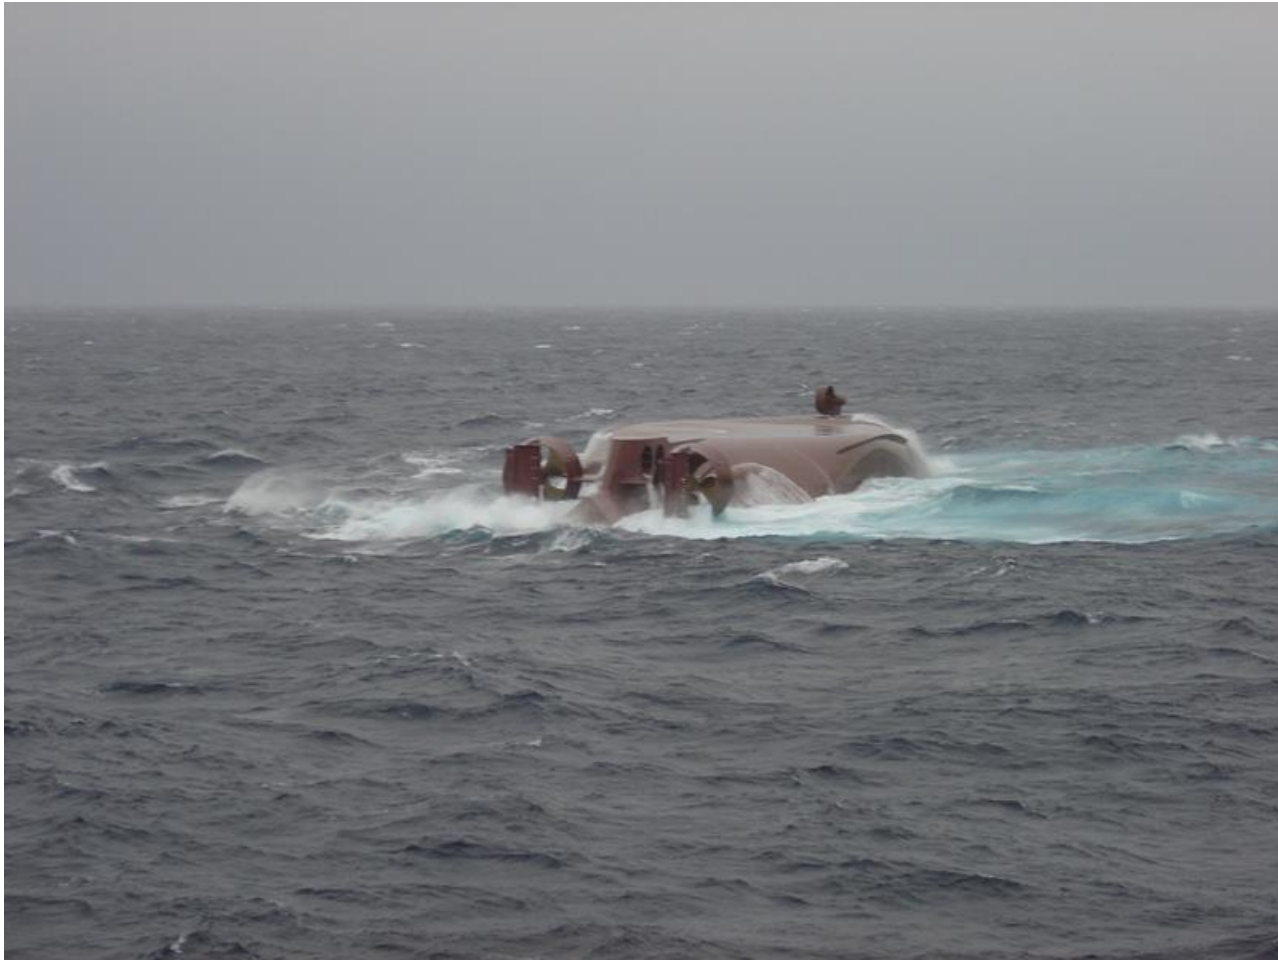
- Major emergency response.
- Other vessels in vicinity.
- Rescue helicopters.
- 7 survivors picked up from sea.
- 3 bodies recovered from sea.
- BD floating in capsized state – still attached to rig by anchor chain.
- Rig down-manned to emergency personnel only.
- SOSREP involved – risk of pollution and to give greatest opportunity for salvage.
